CENTRAL INTELLIGENCE AGENCY

SUBJECT Bore Sighting Range at Mlada Airfield DATE DISTR. 26 August 1955

Memory Sketch Showing Location of Bore Sighting Range at
Mlada Airfield

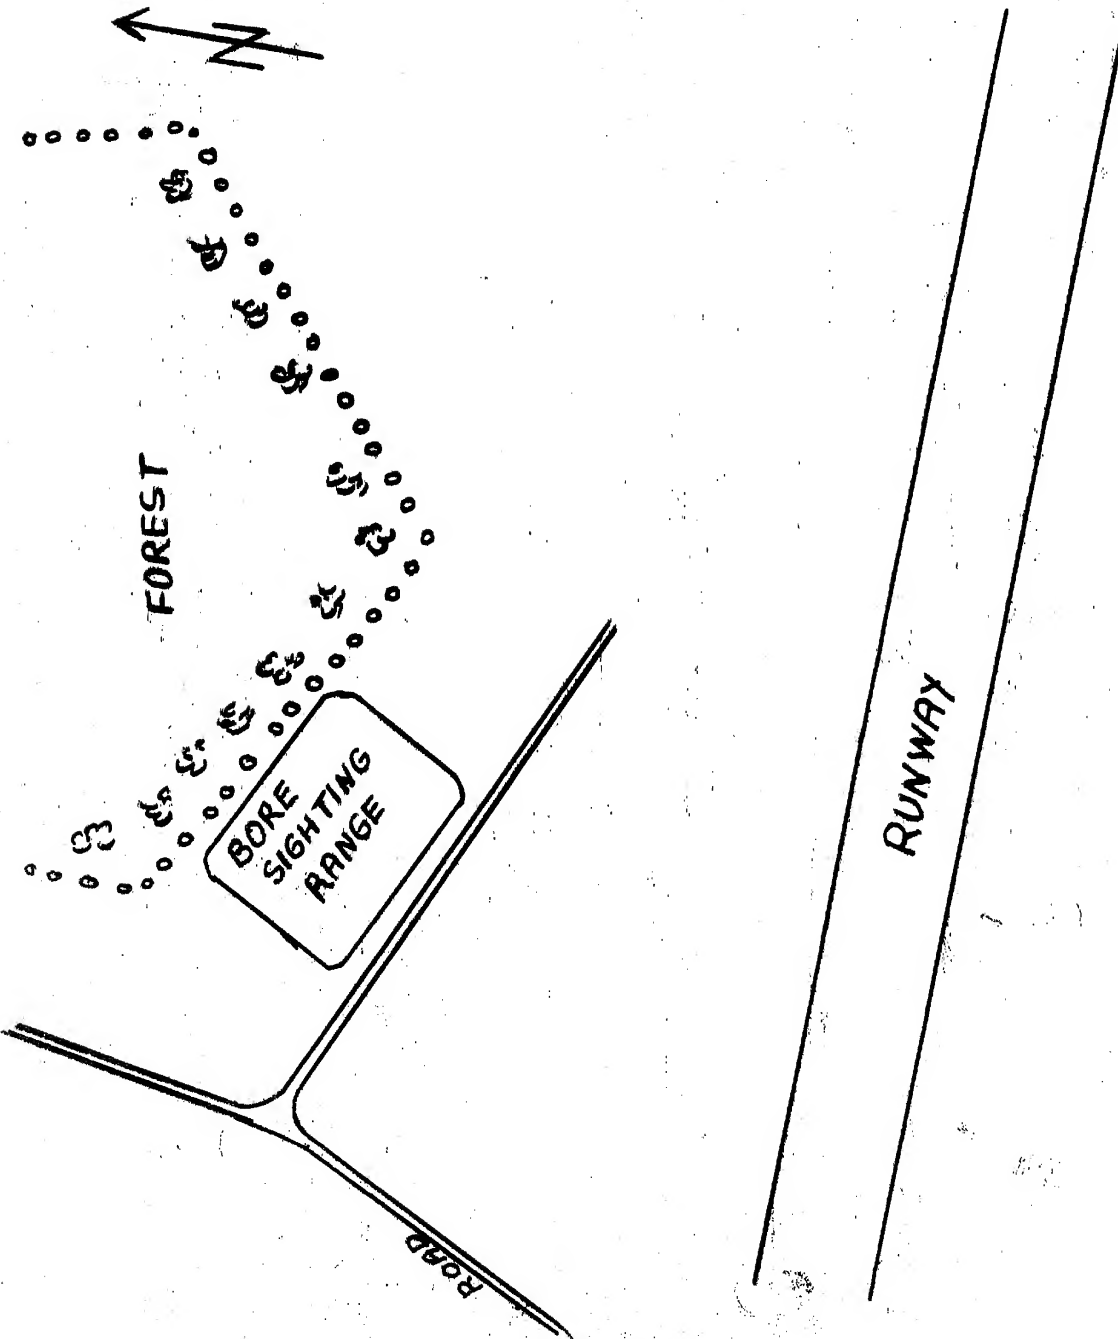
[REDACTED] (See [REDACTED] Sketch, page 2, for location of the bore sighting range at Mlada Airfield.) He saw nine ME-109 aircraft practicing shooting at the target circles from an altitude of 100 m. Troops kept a record of the hits and smoothed the soil. Exercises lasted from 35 to 40 minutes. The 6th Fighter Regiment, which had ME-109's assigned to it, practiced shooting about twice a month; the 2nd and the 7th Fighter Regiments, with MIG-15 aircraft, practiced more than twice a month.

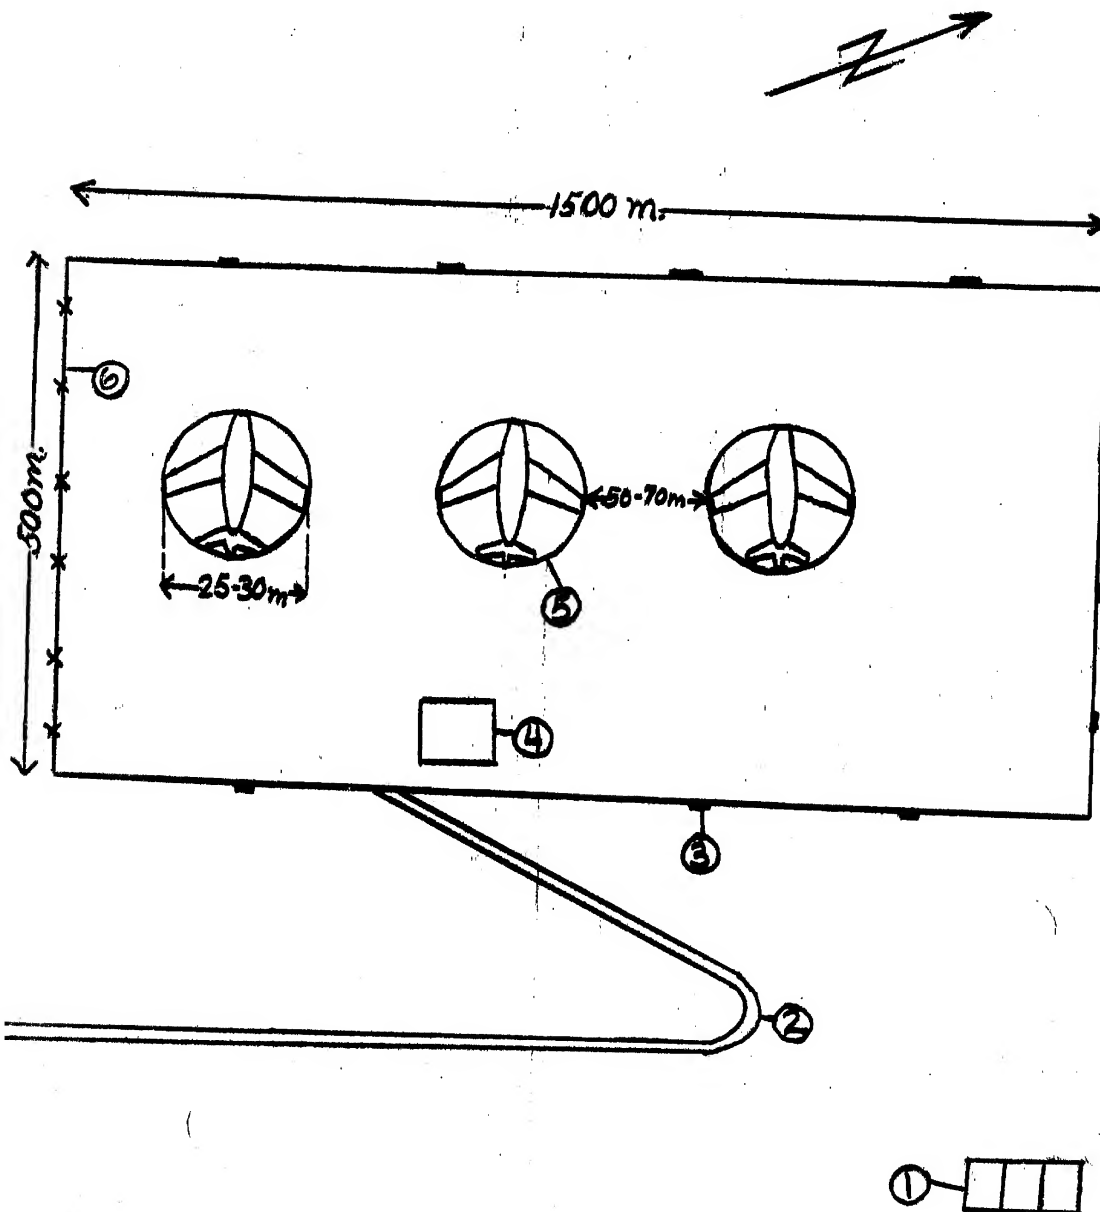
Memory sketch of Bore Sighting Range at
Mlada Airfield

1. Parking space for motor vehicles, not enclosed, hard packed surface. Located about 300 m. east of the bore sighting range.
2. Field road, three meters wide, packed surface, fruit trees on one side. This road led to the bore sighting range.

3. Signs posted around the perimeter of the bore sighting range warning tanks and other vehicles not to enter the range. The signs read: Entrance to Bore Sighting Range Prohibited.

4. Concrete bunker, 10-12 m. wide, 3.5-4 m. high, flat roof. Fifteen men could take refuge in this bunker during shooting exercises.
5. Target with circle outline laid out with 15 cm. wide white painted bricks. The circle measured about 25-30 m. in diameter. An outline of a plane inside the circle was also made of white bricks. The ground within the circle outline and airplane outline was smooth and carefully tilled. Troops from the concrete bunker (point 4) examined the target for hits and smoothed the soil. Source reported three or four of these targets inside the bore sighting range. The ground around the targets was sown with grass. The distance between targets was between 50 and 70 m. The entire bore sighting range measured about 1,500 x 500 m. The terrain inside and around the bore sighting range sloped gently to the north. The bore sighting range was not guarded even when exercises took place.

6. Fence, 50 cm. high, wooden poles, one strand of barbed wire; fenced the area on its south side only.

Legend: Memory Sketch of Bore Sighting Range at Mlada Airfield
